Residential Inspector of America
www.residentialinspector.com
770.476.4963

Sewer Line Evaluation Report

DATE: Jul 16, 2019
CLIENT LAST NAME: Mr. & Mrs. Sample
ADDRESS (street): 123 Sample st.
SEWER LINE INSPECTOR: Douglas Booth
IMAGE OF STRUCTURE:

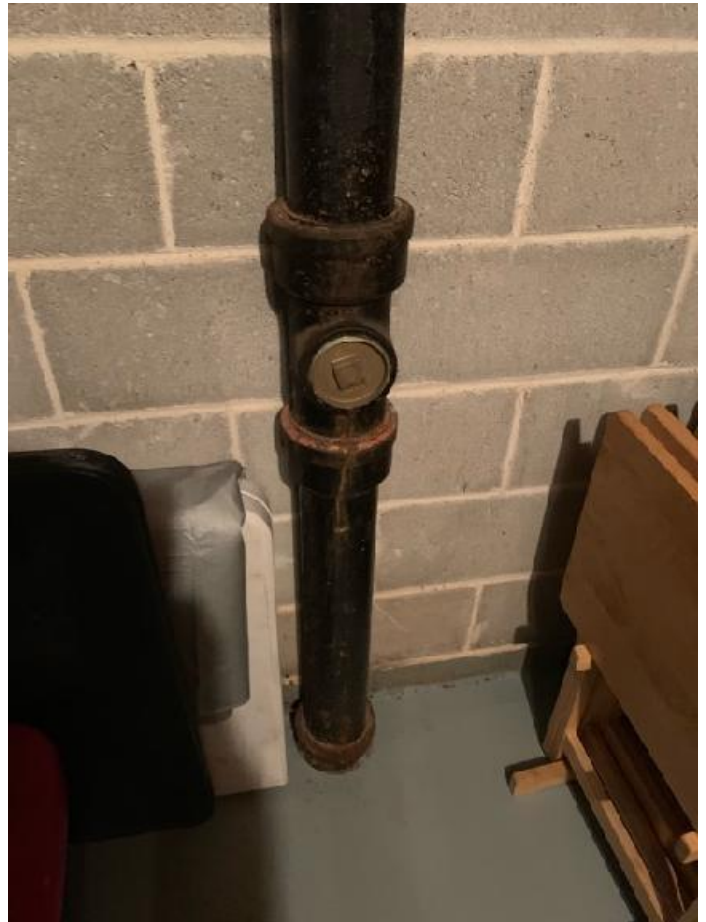
IMAGE OF CLEANOUT(s) (prior to inspection):

LOCATION OF CLEANOUT: Basement
CLEANOUT MATERIAL: Cast Iron

Cast Iron. Average expected life of this pipe is 40-60 years. Repairs/replacement is likely in the near future.

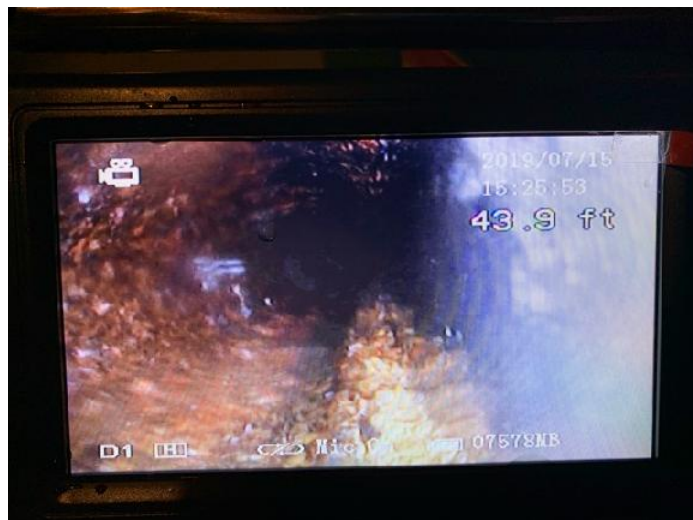
**CAMERA INSPECTION FINDING (1):
IMAGE OF SEWER PIPE INTERIOR:**

Vegetation in sewer line

**APPROX. FOOTAGE FROM ENTRY POINT
WHERE ISSUE (1) IS LOCATED:**

10

The scope encountered a blockage at ~10ft from the entry point. Roots, have intruded the cast-iron from either a failed joint or a crack in the pipe. This blockage is not yet complete and will allow solids to pass, but will likely worsen with time leading to unwanted backups. We highly recommend further evaluation by a licensed professional to repair or replace this area of the drain line as needed.

A licensed professional should evaluate the issues noted in this report
Additional inspection is recommended due to issues noted in this report
